PROBLEMS WITH OVERLAYS IN VNA AISLES

OVERLAY IN A VNA AISLE – CASE STUDY

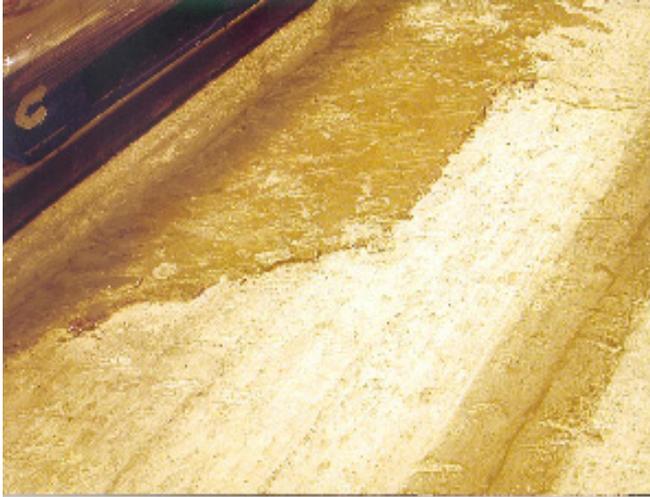
The screed material in the photos (left and below) was installed in an attempt to provide Category 2 floor flatness tolerances, in 22 aisles 60 metres long. As the pictures clearly show, **IT FAILED**. Literally!

Not only was the original floor flatness made noticeably worse, the screed began to break apart within weeks of the narrow aisles being put into operation.

Potholes and loose chunks of screed material created huge maintenance problems to the client’s fleet of VNA forklift trucks.

After a lengthy legal process, Concrete Grinding were called in to rectify the problems, and provide the client with the Category 2 floor that they required.
