COGRI AUSTRALIA PTY LTD

Floor Joint Repairs

Joint "Reseal" Repair

Joint "Arris" Repair

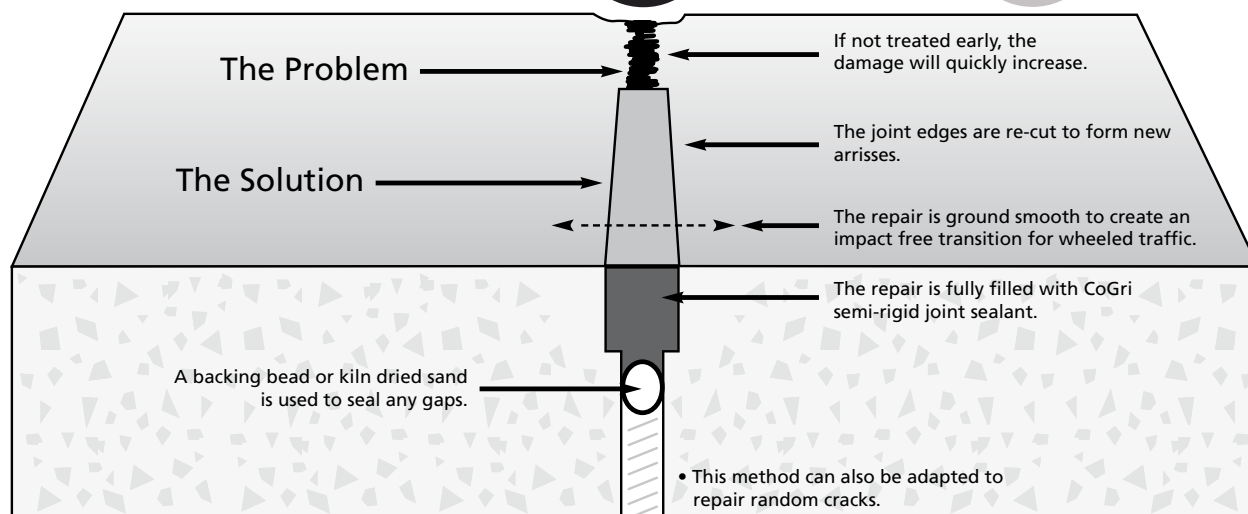
Existing Problem:

Hard wheeled traffic deflects any existing 'soft' sealant and impacts against the joint arrisses, causing 'spalling'.

The Solution:

Damage to joint is reduced/prevented by implementation of semi-rigid joint sealant. Warehouse traffic experiences smooth transition across joint.

Using the joint reseal detail (below) in conjunction with CoGri semi-rigid joint sealant, we can reduce or even prevent further edge spalling. However, this relatively simple repair process can only be utilised if the edge damage is detected at an early stage. If more serious damage has already occurred we would need to re-construct the joint 'arrisses' by using the repair method overleaf.

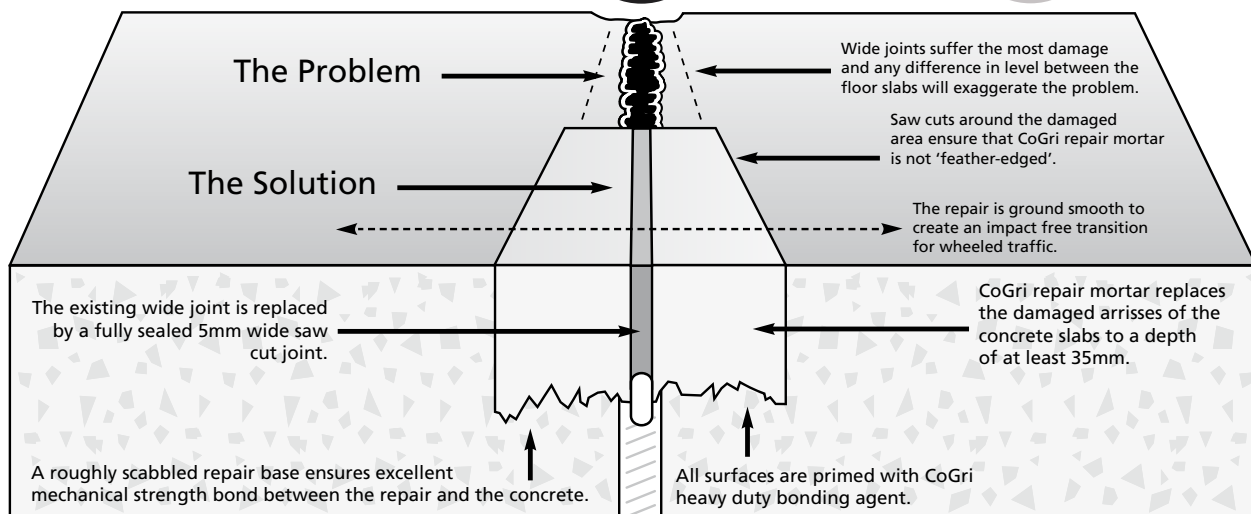
Existing Problem:

Hard wheels and heavy impact loads from materials handling equipment cause major damage to the joint arrisses.

The Solution:

New extremely durable joint system provides a smooth surface on which warehouse traffic can pass, potentially reducing maintenance costs to MHE.

Wide joints increase the risk of arris spalling due to the deflection of the joint sealant under load. It is therefore important to reduce the width of the joint opening at surface level. Our tried and tested joint arris repair detail (shown below) allows a 50mm wide 'traditional expansion joint' to be replaced with a neat 5mm wide, fully sealed saw cut. Each of our repairs are ground smooth and flush with the adjacent floor surface to ensure that wheeled traffic has a smooth transition over the repaired joint.
